NBSIR 74-390

ELECTROMAGNETIC NOISE IN ITMANN MINE

Electromagnetics Division
Institute for Basic Standards
National Bureau of Standards
Boulder, Colorado 80302

June 1974

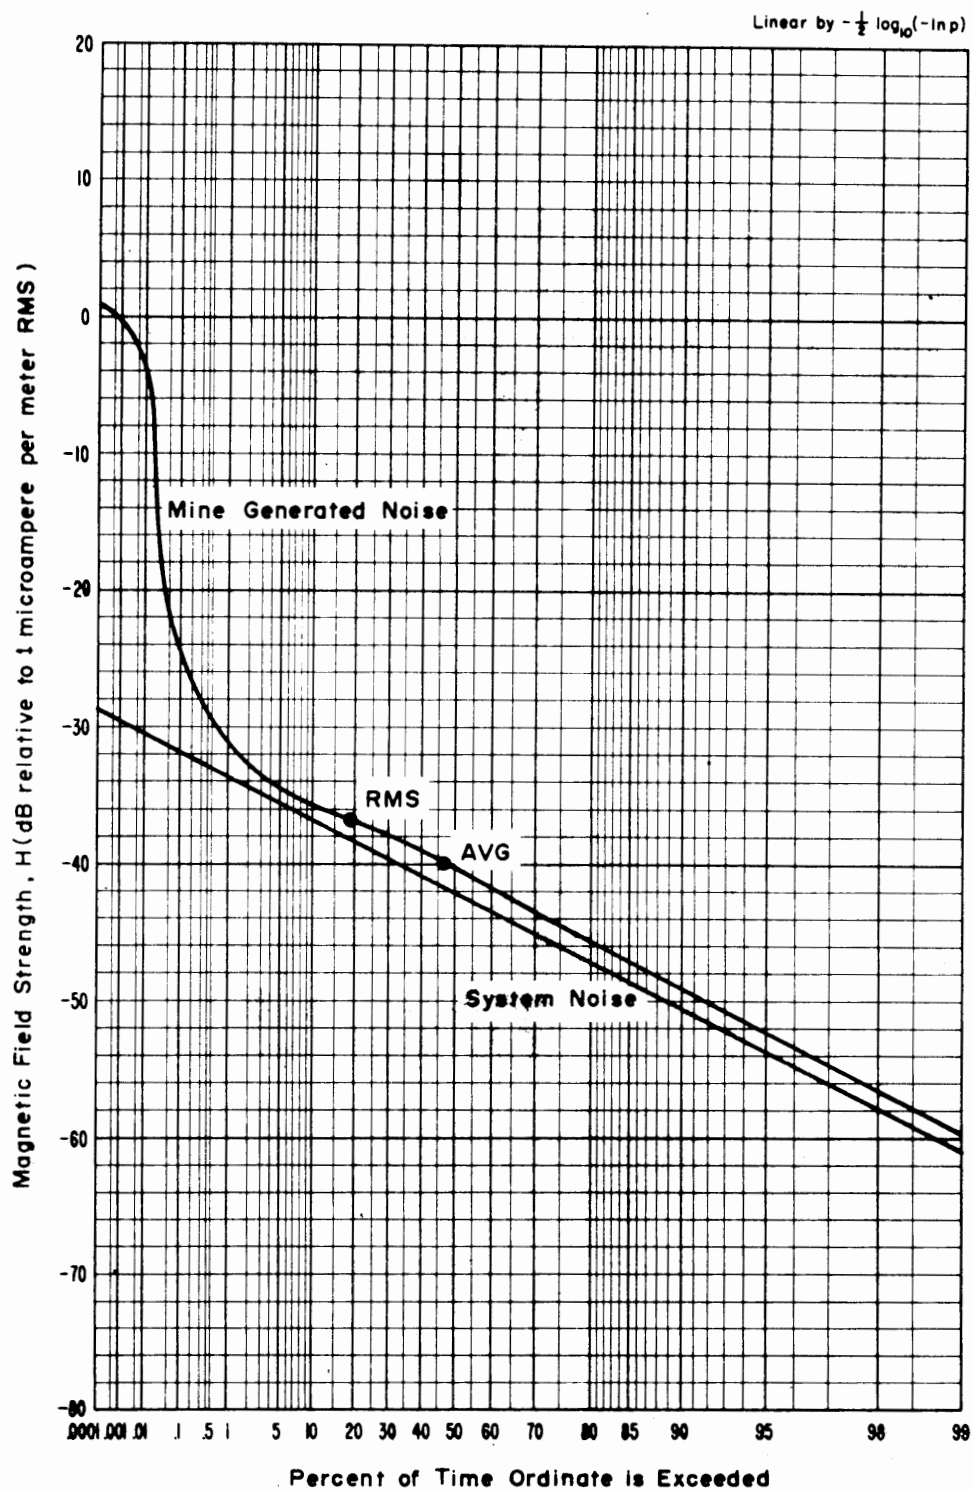
Figure 4-38 APD, 6 MHz, vertical component, 1.2 kHz predetection bandwidth, April 19, 1973, 12:00 p.m., Farley Headpiece, Itmann #3.

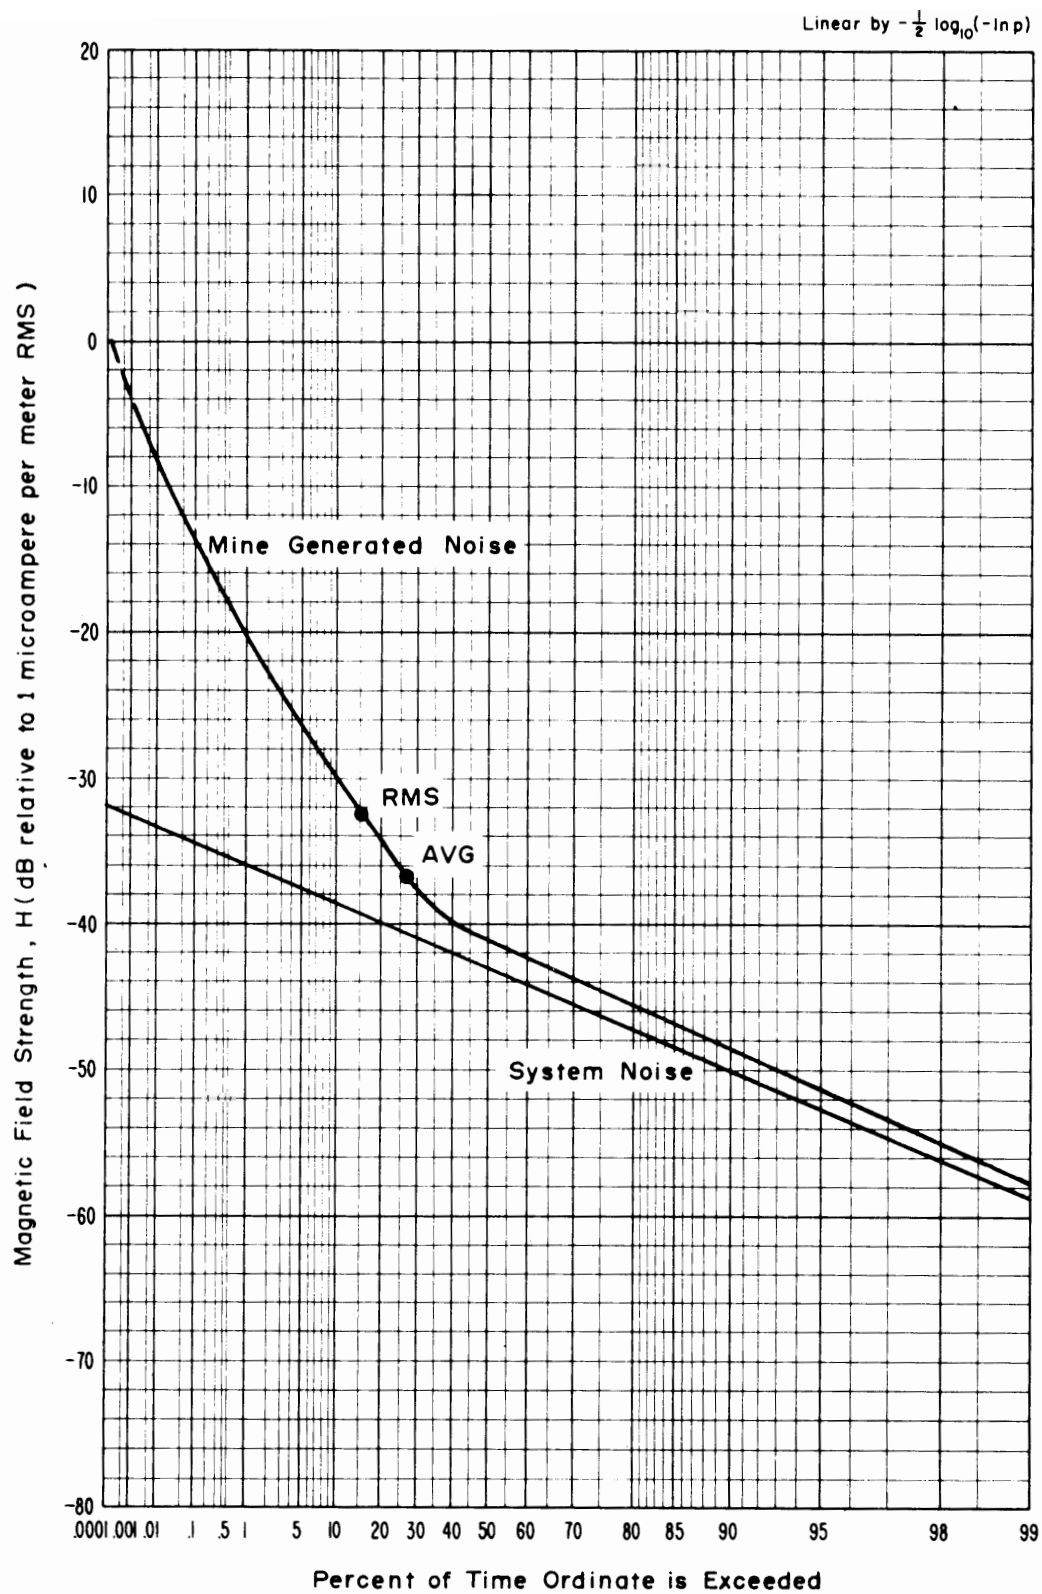
Figure 4-39 APD, 14 MHz, vertical component, 1.2 kHz predetection bandwidth, April 19, 1973, 12:30 p.m., Farley Headpiece, Itmann #3.

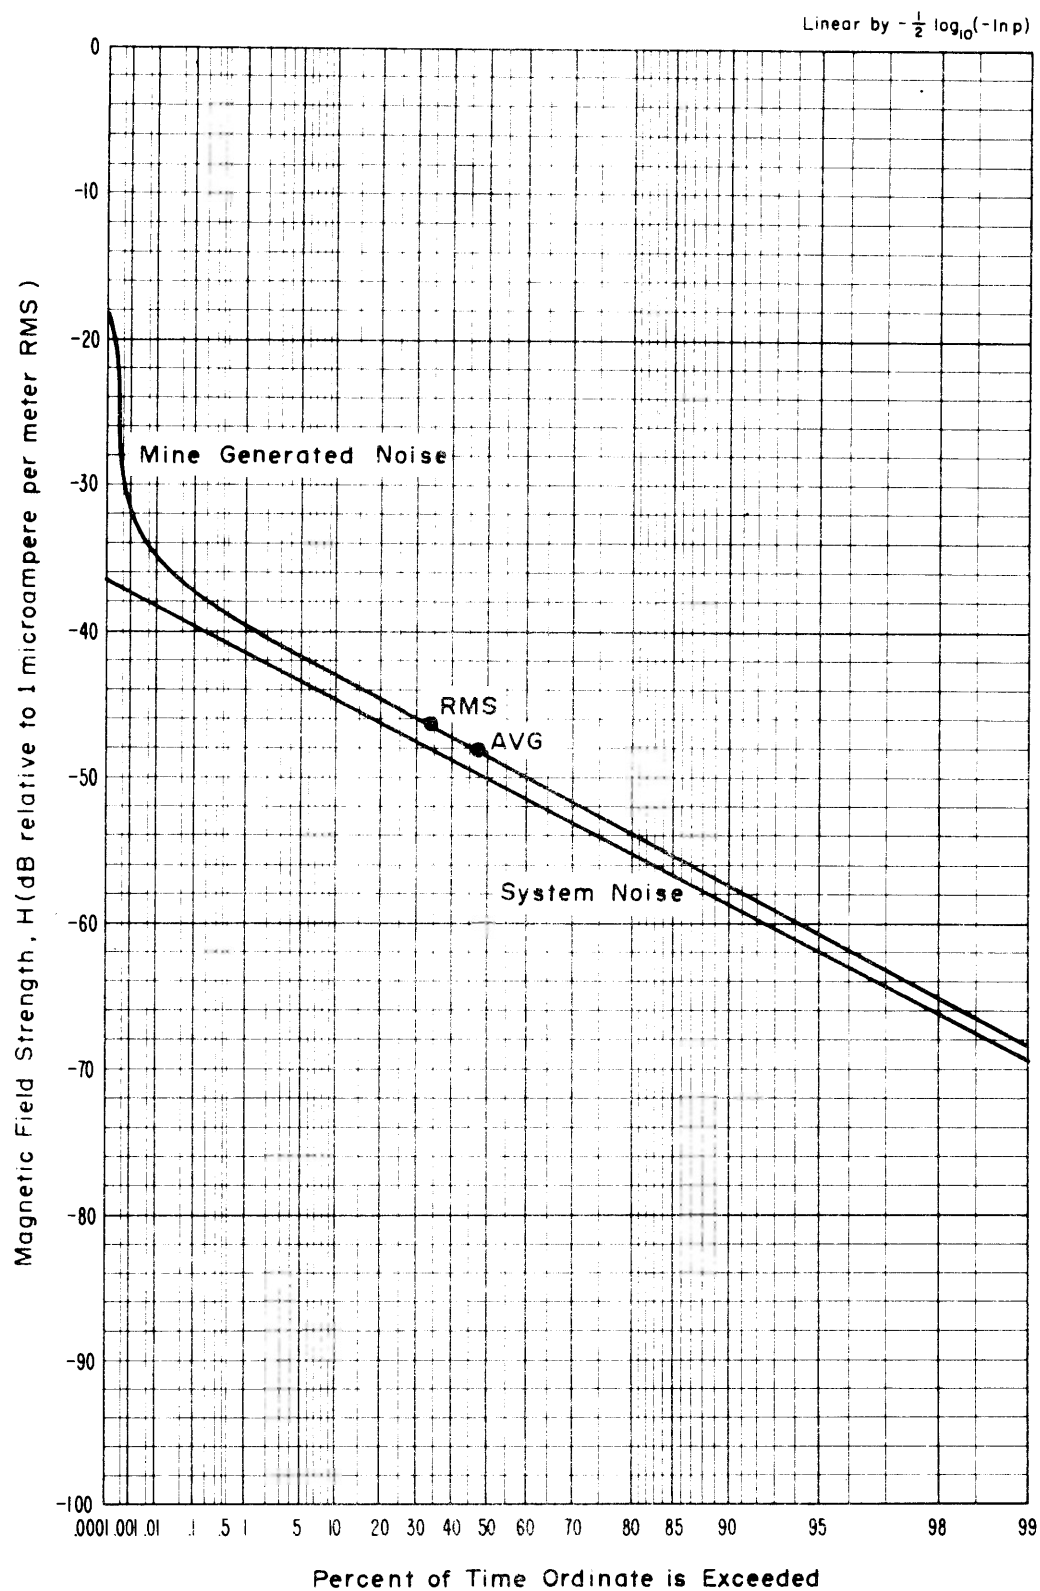
Figure 4-40 APD, 32 MHz, vertical component, 1.2 kHz predetection bandwidth,
April 19, 1973, 1:00 p.m., Farley Headpiece, Itmann #3.

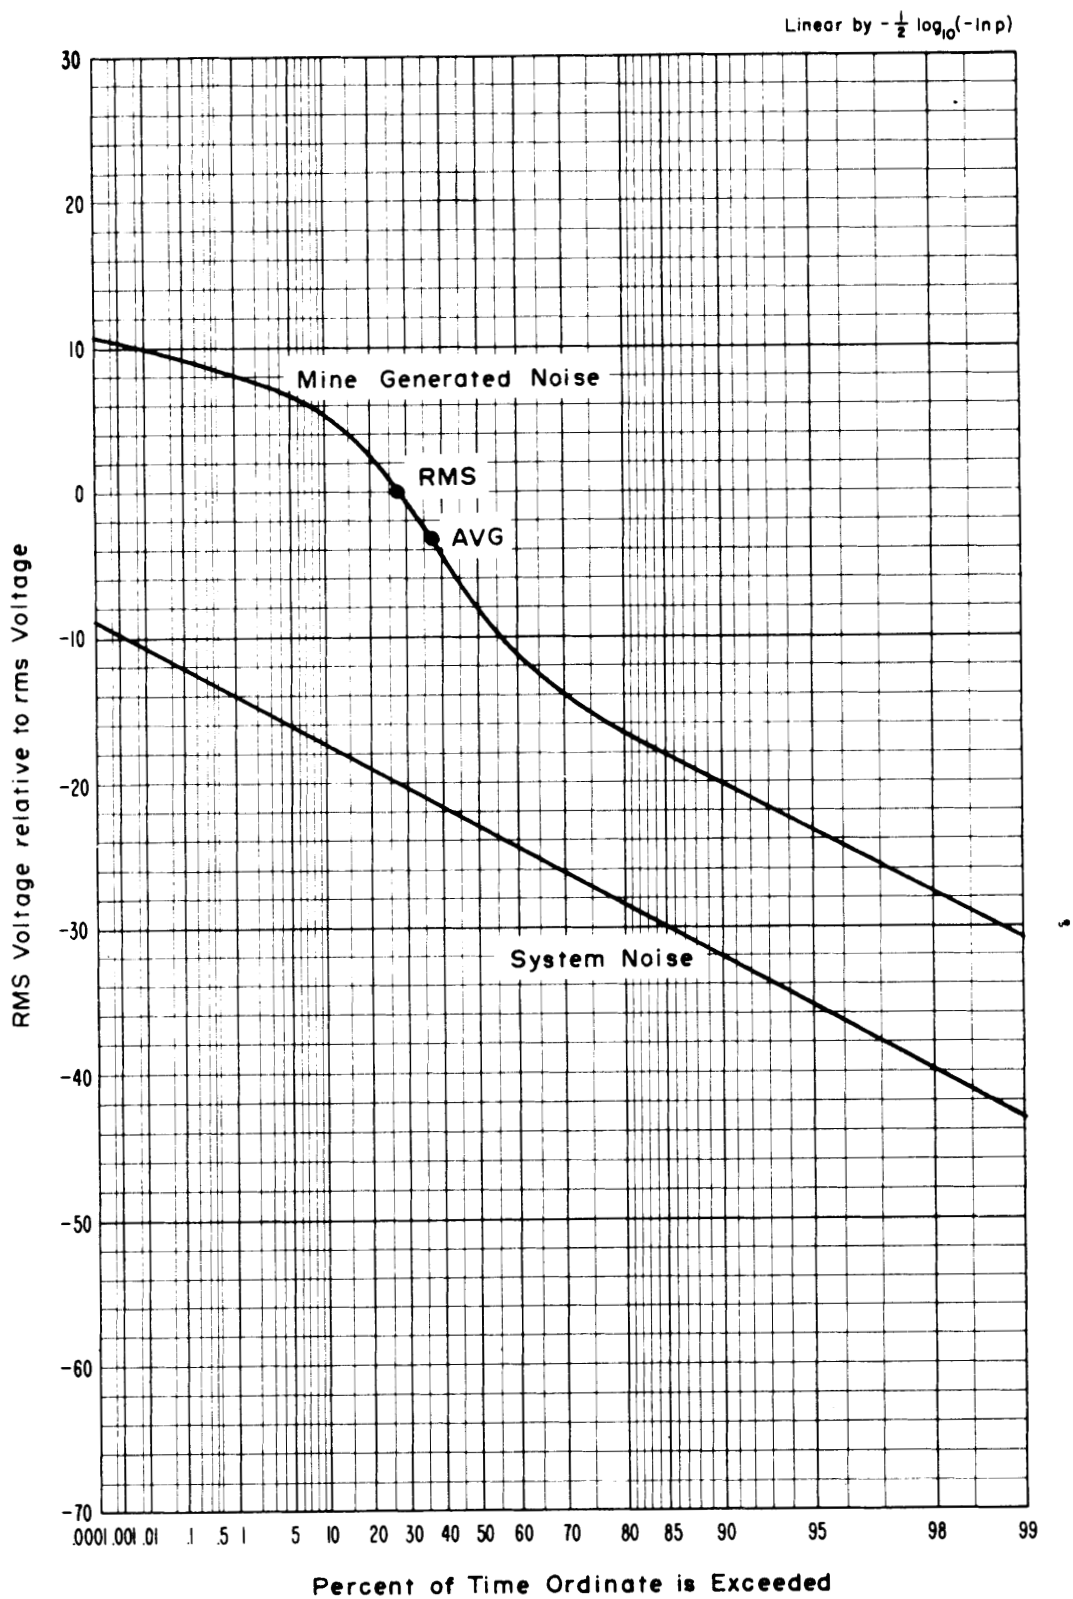
Figure 4-41 APD, 10 kHz, roof bolt measurement, 1.0 kHz predetection bandwidth, April 19, 1973, 1:30 p.m., Farley Headpiece, Itmann #3.
